# Fukushima Accident : An overview

## 3.11 Earthquake and aftershocks

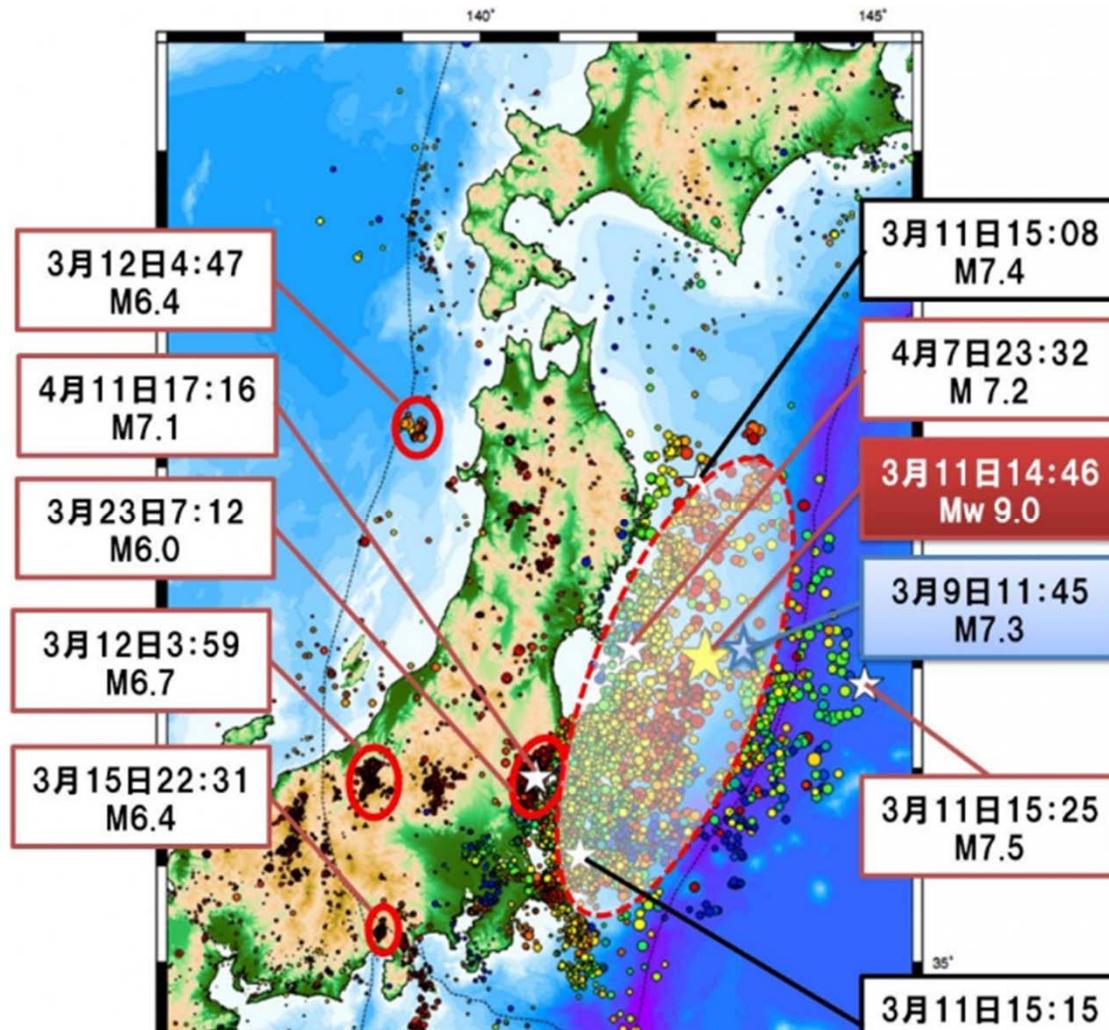
### Statement by the Headquarter for Earthquake Research, 11March2011

The Earthquake Research Committee evaluated earthquake motion and tsunami for the individual region off-shore of Miyagi prefecture, to the east off-shore south of Sanriku along the trench, and to the south off-shore of Ibaraki prefecture, but occurrence of the earthquake that is linked to all of these regions is “out of hypothesis”.
